Mechanical Response of Titanium Aluminide (TiAl₃)

ARL-CR-0669

June 2010

**Dynamic Science, Inc.
1003 Old Philadelphia Rd., Suite 210
Aberdeen, MD 21001**

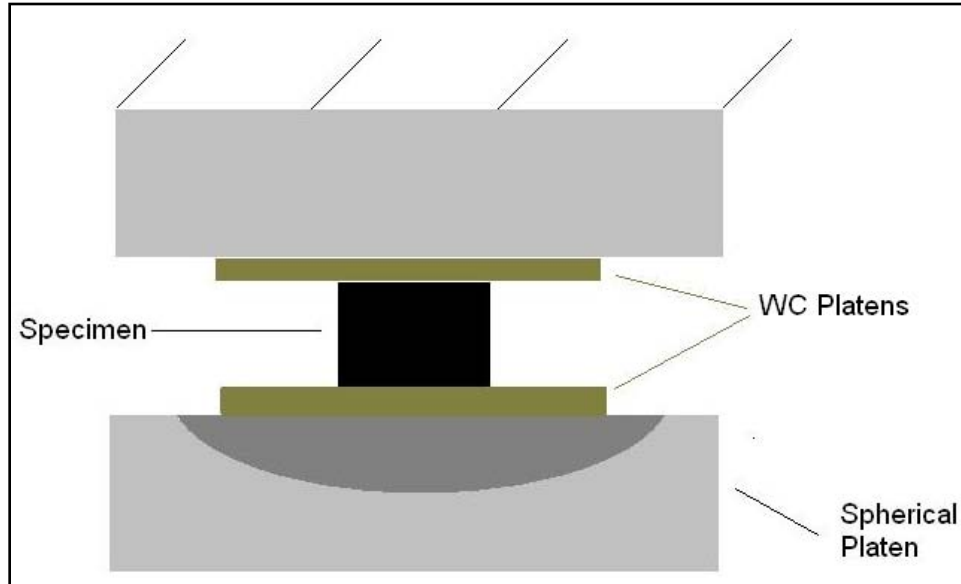
Figure 2. View of test setup with spherical platens.

Brittle materials can also be sensitive to non-centric loading due to non-parallel platens or even from their own loading surfaces. Three techniques were used to mitigate these issues. To eliminate any initial “settling” that was contributing to irregularities in the data some samples were loaded twice. In the table the notation “a” denotes a test where the specimen was loaded to a point below the yield stress and released. The “b” notation refers to the experiment in which the same specimen was compressed to failure. To deal with possible specimen irregularities, the loading faces of specimens 6–10 were finished (600 grit) with an Allied Techprep polisher, a machine designed for precise parallel polishing. Finally, specimens 7–10 were loaded with a spherically articulating platen in line with the load cell. This platen rotates slightly to minimize effects due to non-parallel load faces of either the specimen or the machine. A sketch of this test setup is shown in figure 2.

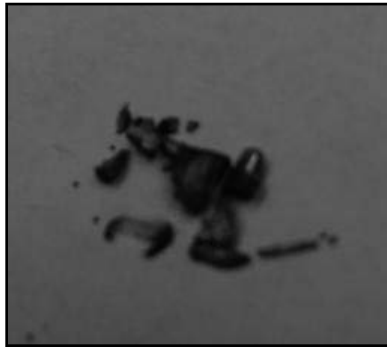
Figure 3. Typical failed low rate specimen.

As discussed above, most of the experiments were not well-suited to measure stress-strain curves and only the failure stress. All of the specimens failed catastrophically with little noticeable plastic deformation, see for example the recovered specimen in figure 3. This sort of behavior is typical of ceramic-like materials. Also, because of its low ductility, it is reasonable to assume TiAl_3 to be linear elastic to failure ($\sigma = E\epsilon$). To evaluate the accuracy of this assumption the stress-strain curves shown below include the assumed linear elastic curve with slope equal to the measured elastic modulus from table 1.

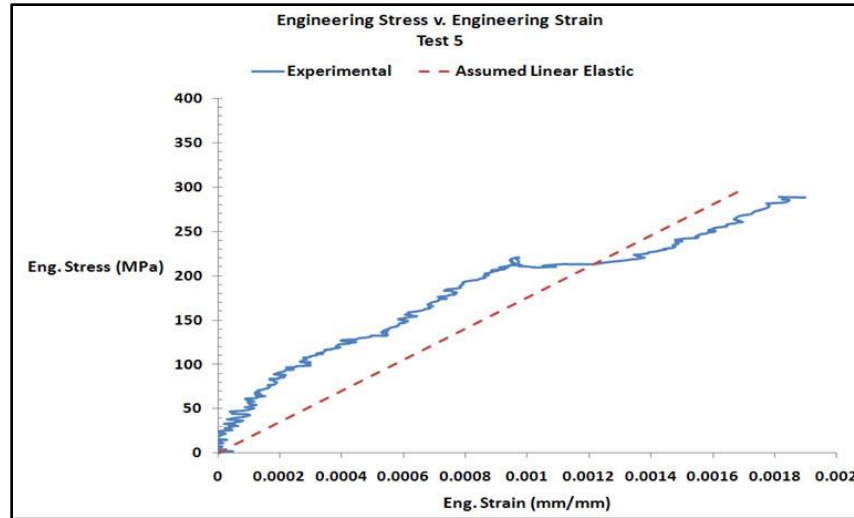
Figure 4 shows the stress-strain curve from Test #5. Specimen strain is measured with a strain gage mounted on the specimen. In light of the error associated with the small strain measurements the data is in good agreement with the assumed elastic modulus. It is noteworthy that at 230 MPa it appears as though the material begins to yield. It is unclear whether this portion of the graph represents actual material behavior or is the result of gage error. This specimen failed at a stress of 300 MPa, i.e., the strain gage survived the entire test.

Figure 4. Stress–Strain curves calculated from strain gage data and theoretical linear elastic behavior based on ultrasound measurements.

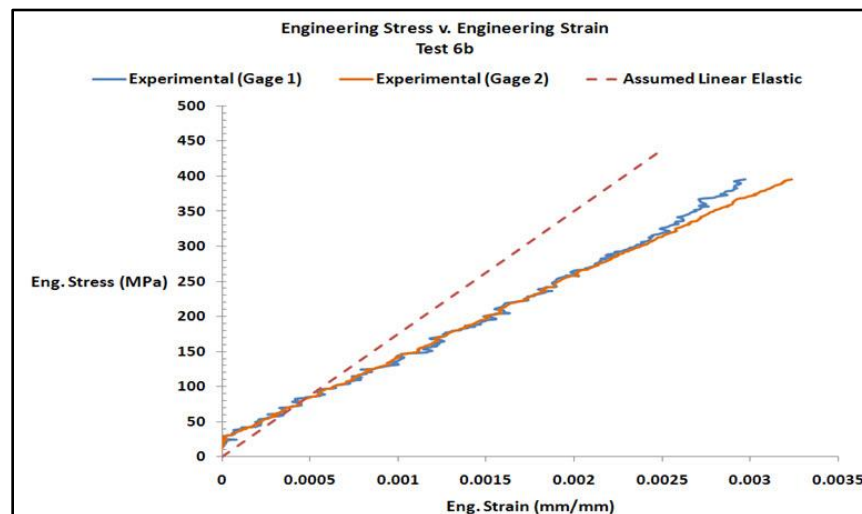
The results from Test 6b are shown in figure 5. Two strain gages were bonded to this specimen, diametrically opposed and oriented to measure longitudinal strain. The figure only shows the material response up to gage failure. During Test 6a, the initial loading of this specimen, not pictured) the gages did not measure identical strains, indicating some non-centric loading that was reduced as a result of the preloading. The elastic modulus from the data in figure 5 is approximately 131 GPa, about one quarter less than the value measured from ultrasound. It is, however, strongly linear.

Figure 5. Stress–Strain curve for pre-loaded specimen compared to theoretical linear elastic curve.

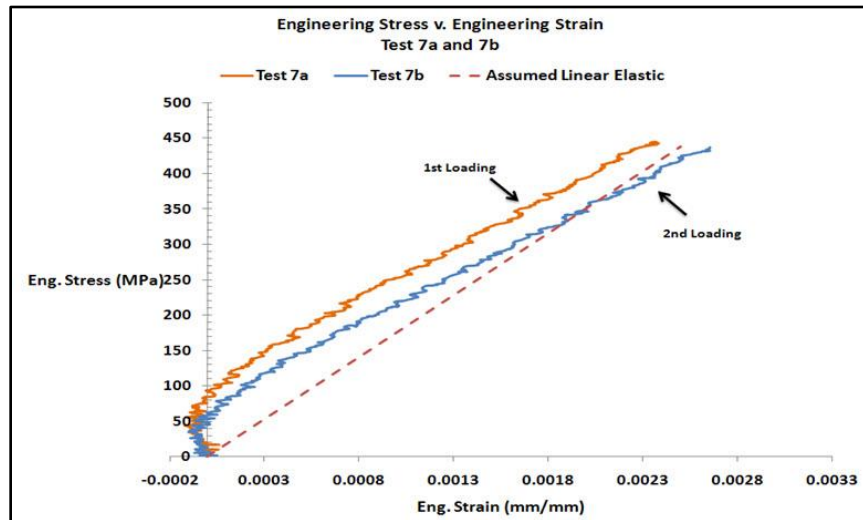
Tests 7a and 7b repeated the previous experiment, but incorporated a spherical platen. The results are shown in figure 6. The data suggests that an initial stress of 50 MPa was attained before the specimen began to compress, but this is attributed to measurement error rather than

actual material behavior. The specimen response was linear in both tests and was reasonably close the linear elastic line. This setup was used to conduct several more experiments, and yielded somewhat inconsistent results due to specimen variation.

Figure 6. Stress–Strain curves for Tests 7a and 7b incorporating spherical platen.

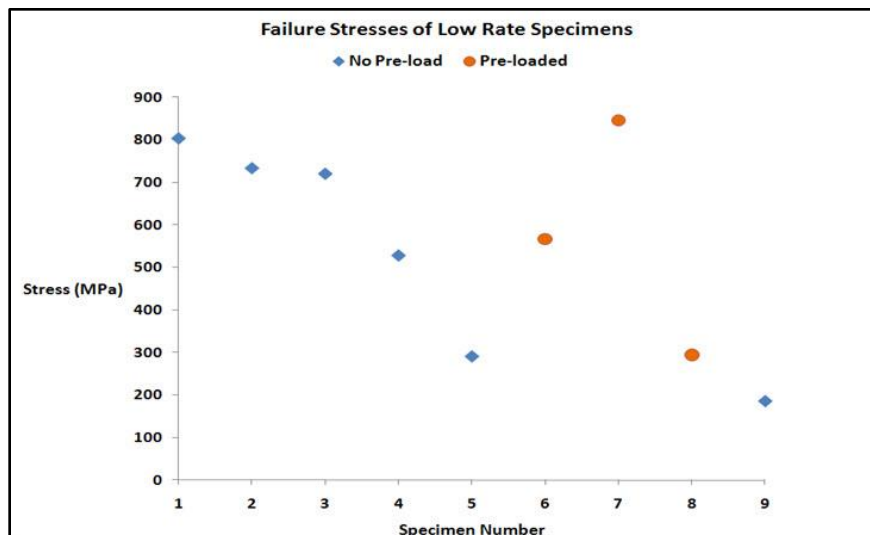
The failure stresses for each of the low rate experiments are reported in figure 7, and the strain rates can be found in table 3. As expected, there was difficulty pinpointing a single failure stress for the material as illustrated by the scatter in the graph. Despite incorporating a spherically articulating platen and sanding specimens the variation persisted. Defects in the specimens arising from the manufacturing process are suspected to be the cause of the scatter.

Figure 7. Failure stresses of low rate specimens.

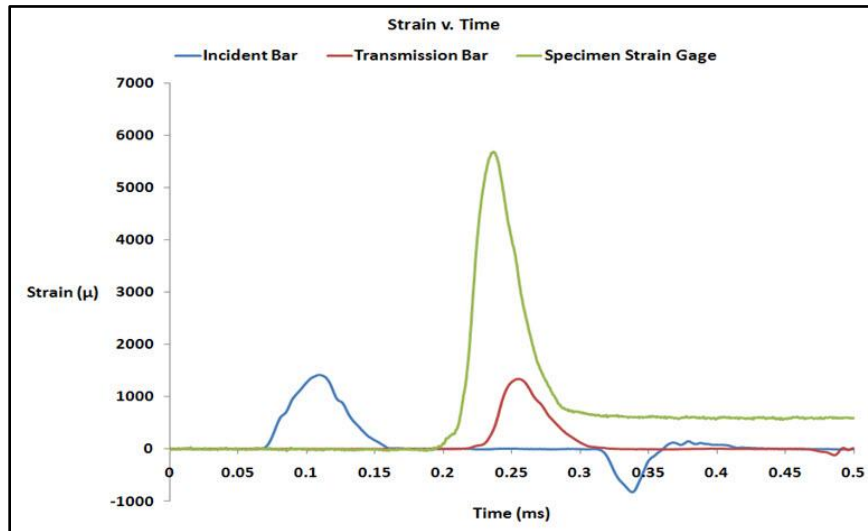
Figure 8 shows representative time dependent strain signals from one of the SHPB tests. The red and blue curves are the strain pulses that occur in the incident and transmission bars, respectively. The incident pulse is triangular due to the copper wave shaper that was placed on the impact end of the bar. Using the shaper allowed specimens to be tested at a constant strain rate and reduced wave dispersion in the bars. The green curve represents the data acquired from the strain gage on the specimen. The gage data shows that in this test the specimen was compressed at a roughly constant rate to approximately 6000 micro-strain, at which point it began to unload. The signal does not return to zero because some plastic strain was experienced.

Figure 8. Strain signals from SHPB test.

A stress strain curve was calculated from the signals in figure 8 and is shown in figure 9. The specimen used in this experiment was tested at a strain rate of approximately 400/s and did not fail. The specimen was loaded to approximately 900 MPa, experienced very little plastic strain, and then was unloaded. There is a strong agreement between the experimental data and the assumed linear elastic behavior. This provides some validation of the modulus of elasticity calculated from the ultrasound measurements and indicates that the strain gage data accurately measures real material behavior.
